Condensation In Headlamps –
Revised Headlamp Cap Available –
Repair Procedure

MODEL 2002-04 MY
X-TYPE

VIN C00001-E06300

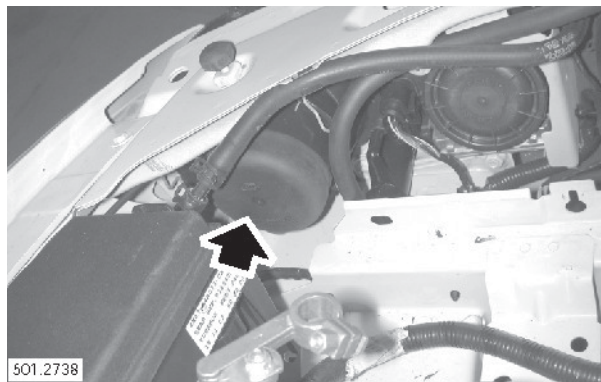
ILLUSTRATION 1

Some 2002-04 MY X-TYPE vehicles within the above VIN range, may exhibit condensation buildup within the headlamp assemblies. A revised cap for the low beam (outer) headlamp has been released to address this concern.

LOW BEAM HEADLAMP CAP

1. Remove battery (see Workshop Manual, section: 414-01, SRO 86.15.01).
2. Unclip the left-hand-side low beam (outer) headlamp cap and remove cap (Illustration 1, left-hand-side shown, right-hand-side similar).

3. Install the new headlamp cap, reposition clips and secure cap.
4. Carry out step 2 and 3 for the right-hand-side headlamp cap.
5. Install battery (see Workshop Manual, section: 414-01, SRO 86.15.01).
