**Front Axle Shafts –
Check Retention In CV Joint –
Service Action S930**MODEL 2002-03 MY
X-TYPE

VIN C00293-C94500

Service Action S930

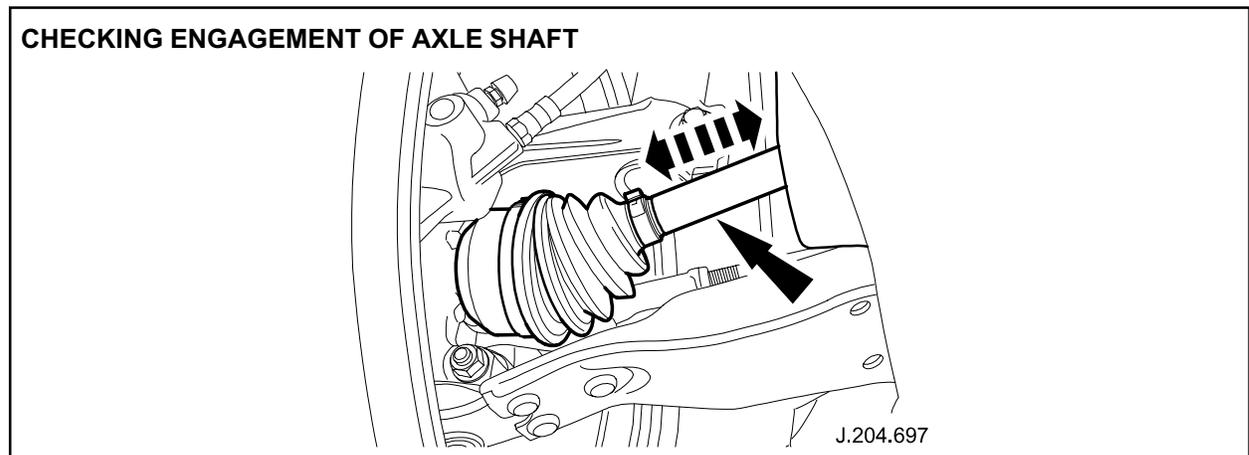
ILLUSTRATION 1

During the manufacturing process it is possible that the front axle shafts may have been disturbed. As a result the splined end may not be fully engaged in the outer Constant Velocity (CV) joint resulting in a loud knocking noise.

2. From under the vehicle grip the first front axle shaft. Push the front axle shaft towards the outer Constant Velocity (CV) joint then pull back the axle shaft towards the transmission (Illustration 1).

3. If movement of more than 1 mm is detected on the outward push, a click indicating engagement of the cir-clip should be felt.
4. If movement is felt on the inward pull and the axle shaft did not come adrift, push it out again to engage.
5. Pull the axle shaft towards the transmission to verify that the axle shaft has engaged. There should now be no movement of the axle shaft.
6. If the axle shaft comes adrift from the outer CV joint when pulled towards the transmission at any time, replace the complete axle shaft.
7. Repeat for remaining front axle shaft.
