X-TYPE

XT501-06

TECHNICAL BULLETIN

Water Leaks In Luggage Compartment – Vehicle Parked Facing Downhill – Repair Procedure MODEL 2002 MY X-TYPE VIN C00001-C90459

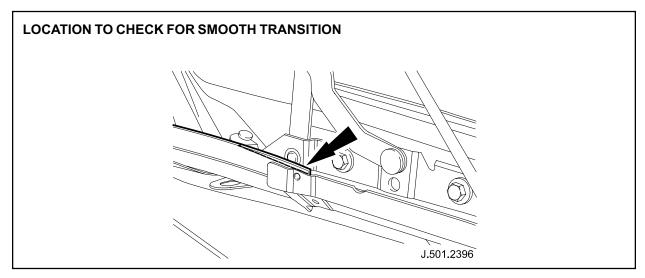
ILLUSTRATION 1

- 3. Use appropriate tar and glue remover to clean seal flange around luggage compartment aperture.
- 4. Ensure there is no step between the upper back panel and luggage compartment lid drain channel. (Illustration 1)

- 5. Remove excess material by filing or grinding.
- 6. Clear all filings from luggage compartment drain channel.
- 7. Coat any bare metal with zinc-rich paint.

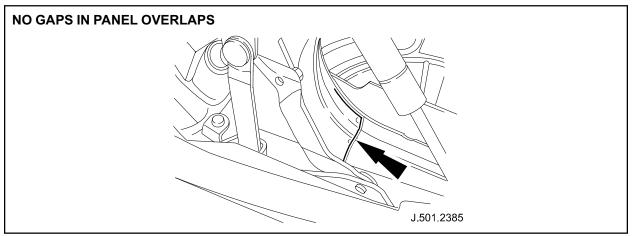
ILLUSTRATION 2

8. Ensure there are no gaps between the panels where they overlap. (Illustration 2)

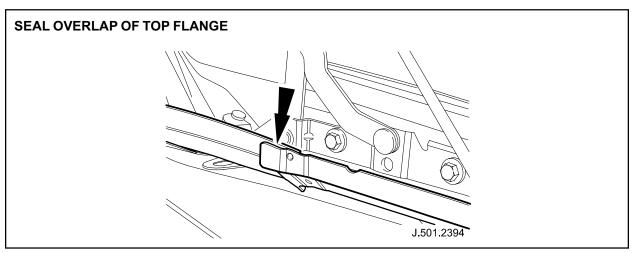
ILLUSTRATION 3

Note: The overlap at the top of flange should be fully sealed to eliminate potential water leak paths. (Illustration 3)

9. Use suitable clear air-drying sealant to seal along path of overlap.
